OCEAN QUAHOG APPENDICES

APPENDIX A1. Survey sensor package data from the 2005 NEFSC clam survey. Differential pressure and other data were analyzed to determine if the pump on the survey dredge performed as expected.

R/V Delaware II Clam Dredge Pump Performance⁷

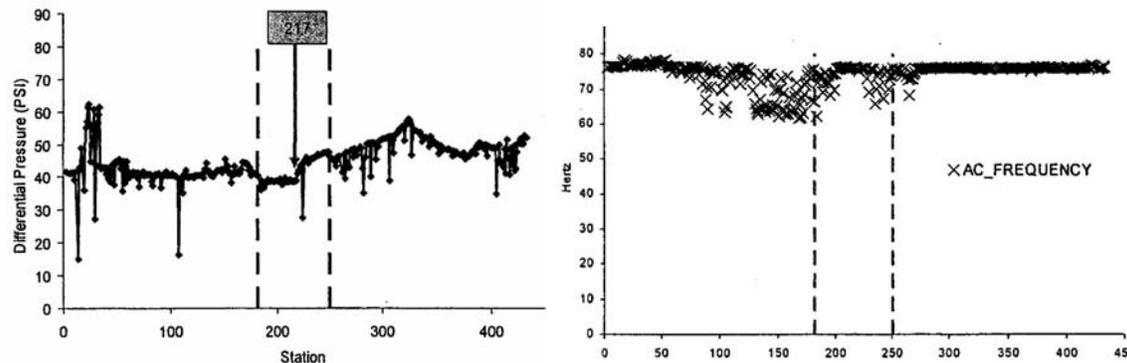
Appendix A1. Figure 1 - SSP Manifold Differential Pressure Figure 2 - AC Pump Frequency

From an initial review of the Survey Sensor Pack (SSP) data, the dredge pump manifold differential pressure showed a significant variation over the course of the survey's three cruise legs (See Figure 1). This variation was sporadic during the first survey leg with the pressure spikes being attributed to blocked manifold nozzles from visual inspections at the dredge's retrieval. This however, can not explain the consistent upward trend in the manifold differential pressure starting in the middle of the 2nd survey cruise leg which continued to the middle of the 3rd leg with a then subsequent small falling trend towards the end of the survey. The numerous and sporadic pressure drop spikes that were also noted were not readily explainable by any events that occurred during the survey cruise.

It was also noted that the frequency recorded also showed a large variation during the ends of the 1st and 2nd survey legs and was consistently higher than the 60 hertz that should have been expected (See Figure 2).

An overheated wire connection on the clam survey package's main breaker was discovered during station 217's tow and temporarily repaired for the remainder of the 2nd survey leg. The clam survey package's main breaker was replaced at the completion of the 2nd survey leg.

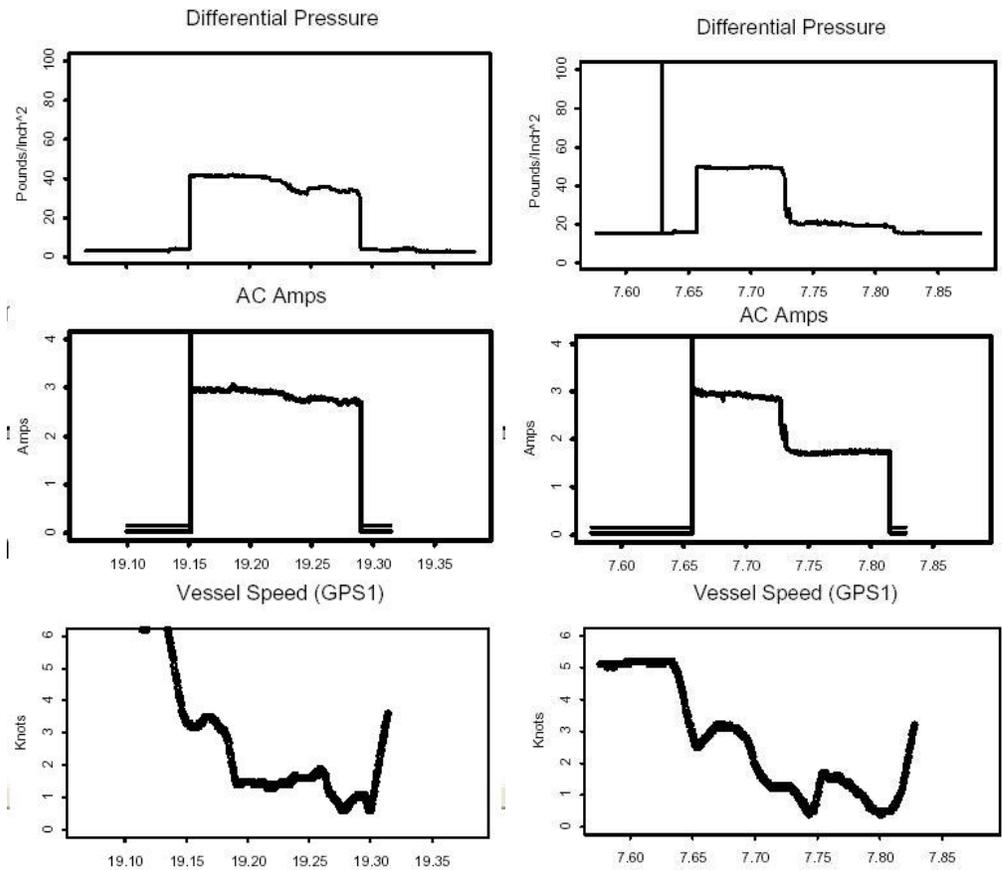
Appendix A1. Figure 3 - Station #71 Tow

The first discovery is the explanation the sporadic pressure drop spikes in the manifold differential pressure. These pressure drop spikes are likely being caused by a temporary blockage of the pumps intake or the pump ingesting the discharge from the dredge manifold which somehow disrupts the pump's intake flow.

Figure 3 shows a typical tow where this pump intake blockage has likely occurred. Note that there is a corresponding drop in the dredge pump's amps draw as the manifold pressure drops. This is typical for a centrifugal style pump such as is on the clam dredge. The drop in pressure could be minor as in Figure 3 or very substantial as shown in Figure 4. Figure 4 is likely an example of the pump ingesting the manifold discharge as it occurred when a very low speed spike, less than 1/2 knots, also occurred.

The visual inspection of the sensor plots also revealed the likely cause for the variation in the general trend of the pump manifold pressure. Using Figures 3 and 4, note that the differential pressures recorded before the pump was started were significantly different. For Figure 3 the starting value is about 5 PSI and for Figure 4 the value is about 15 PSI, a significant difference. Based on this, the following sensor values were graphed on a 10 station interval (those stations with obvious problems were ignored and the next nearest good station was selected, see Figure 5).

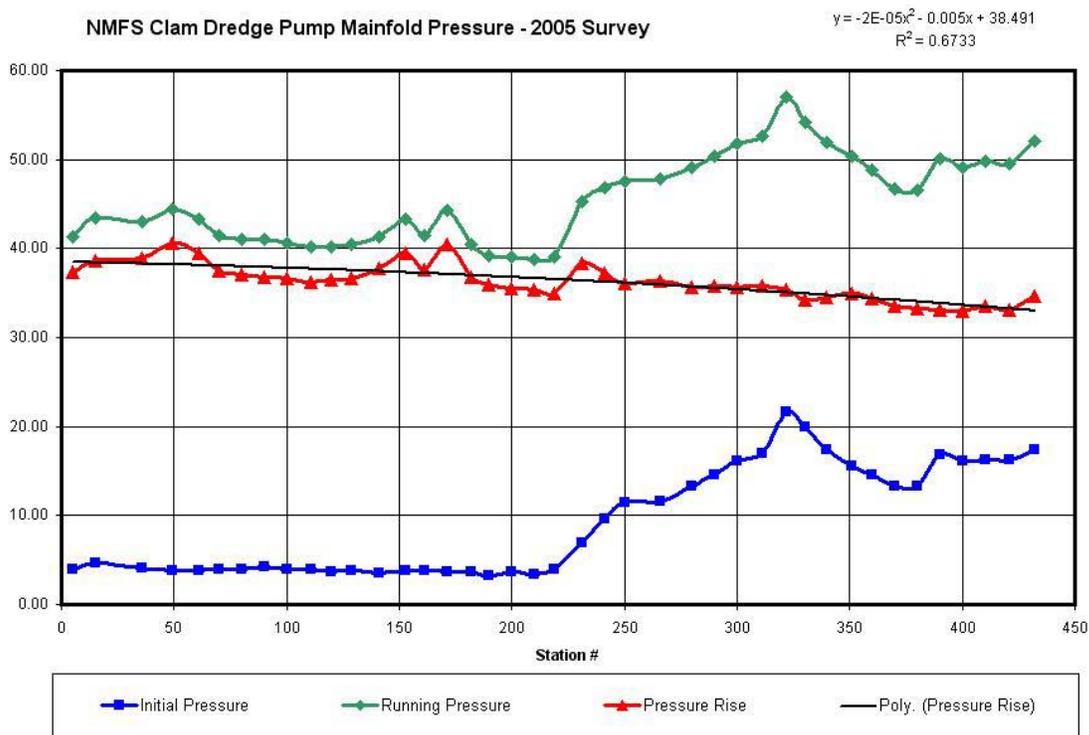
Appendix A1. Figure 5

From Figure 5 the pressure rise in the dredge pump manifold is fairly steady with a consistent downward trend that is typical of a centrifugal pump becoming worn from sand/silt ingestion over the survey. The spikes at stations 49, 153, 171, and 231 are likely due to minor clogging of the manifold nozzles as there is a corresponding drop in the amps draw from the pump. This is shown in Figure 6 which also graphs the amps draw, AC voltage, pump power, and tow depth.

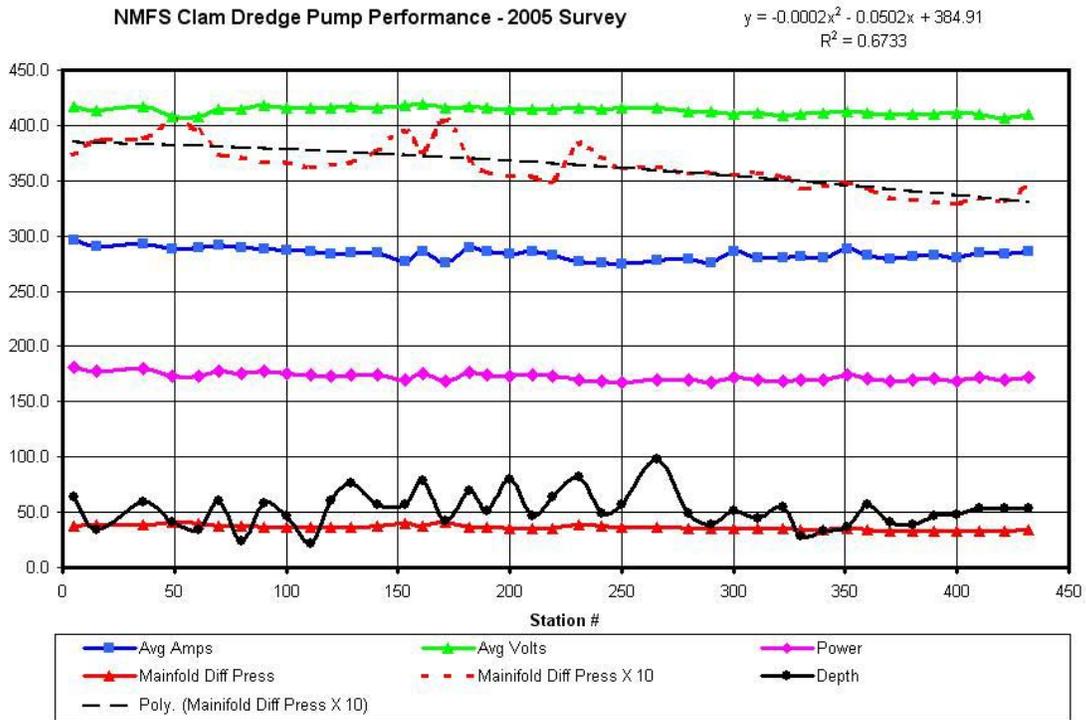
Appendix A1. Figure 6

Based on this the conclusion is the general performance of the clam dredge pump was fairly uniform over the entire survey and the previous noted variations in the manifold differential pressure are likely due to a calibration drift in the SSP sensor. Interestingly this drift starts to occur at about station 217, which is when the problem with the main clam package breaker was noticed and repaired. How the breaker problem could cause a sensor drift is not known as the SSP package uses an internal DC battery completely separate from the AC system containing the clam package breaker.

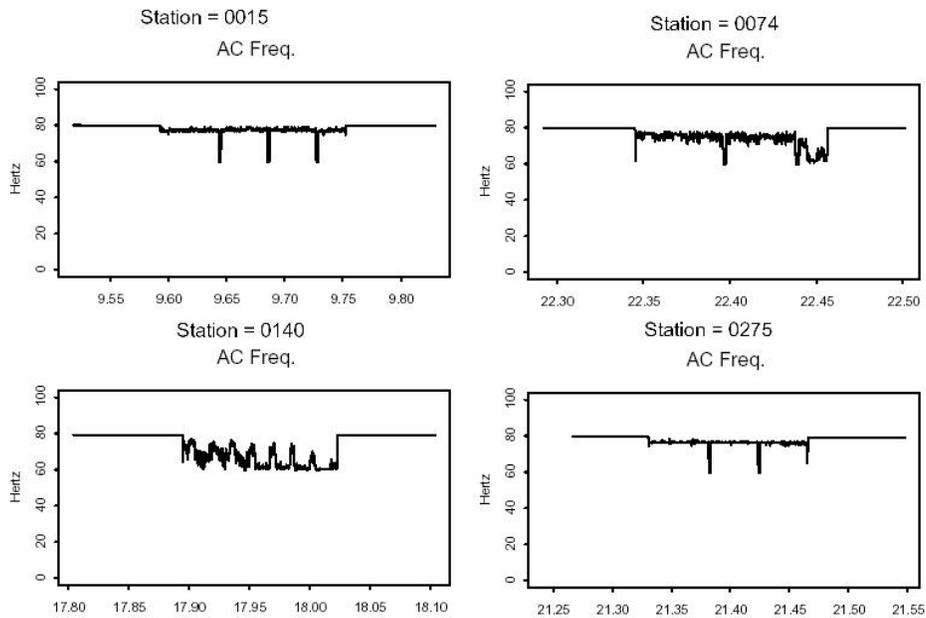
Appendix A1. Figure 7

The variation that occurred in the recorded frequency remains a mystery even after the review of the sensor plots and conversations with the ship's engineer. The value should be very steady and between 59 and 61 hertz which is the output from the ship's generator. Figure 7 shows the typical variation in frequency that occurred during the survey.

The frequency was fairly steady at the start of the survey, and then started a gradual degradation during the last half of the survey's first leg. This degradation in recorded values was not consistent with wide variations between tows. Shortly after the start of the 3rd leg at about station 271, the problem appears to have cleared itself and the frequency was very steady for the remainder of the survey. While there is no direct explanation for this change, it does not appear to have had any effect on the performance of the clam dredge. The hertz values seen by the pump during the survey are likely have to been the steady standard 59 to 61 hertz values shown on the ship's main switchboard. The changes are likely a problem is in the calibration of the sensor for the frequency not being at 60 hertz and some type of sensor interference for the variations experienced.

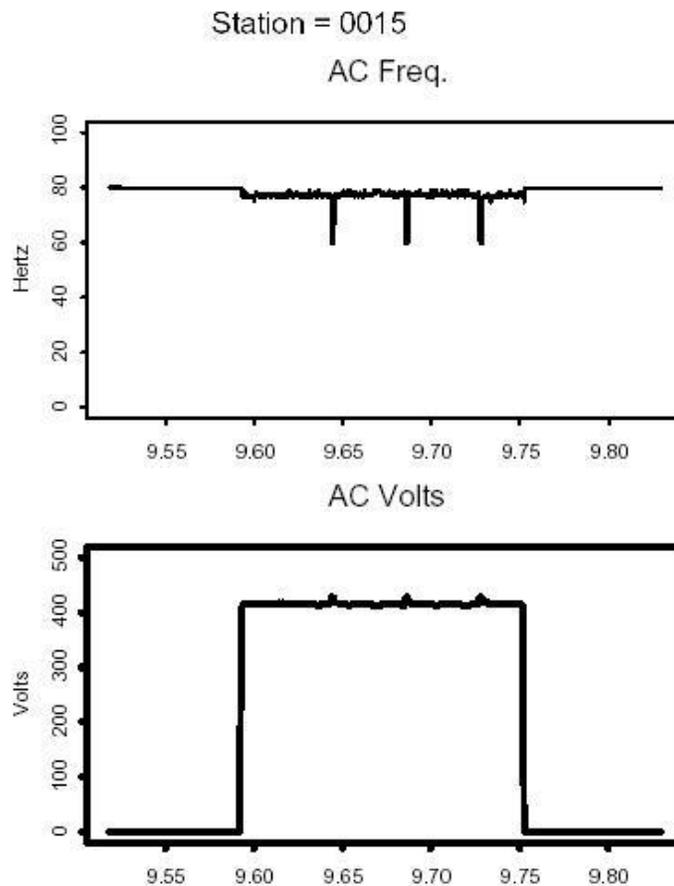
Appendix A1. Figure 8

The last observation from the sensor plots and data is the occurrence of a rhythmic spike in the AC frequency and volts sensor plots. This occurred throughout the entire survey and a typical example is shown in Figure 8. As with the frequency variation discussed above this appears to be a sensor problem. First it is impossible for a generator to vary its speed as would be shown in the frequency plot. In addition there is no corresponding spikes in the amps or pump pressure that should occur if the volts were truly spiking.
